TAT-8310-05

On 14 and 17 October 1983, officers from the Illinois Department of Law Enforcement, Division of State Police, and TAT member Stofferahn conducted inspections of six sites in the Chicago area being used to store cyanide contaminated film chips. These visits were made to assess the structural integrity of the semi-trailer vans which are holding the waste.

### SITE ASSESSMENTS

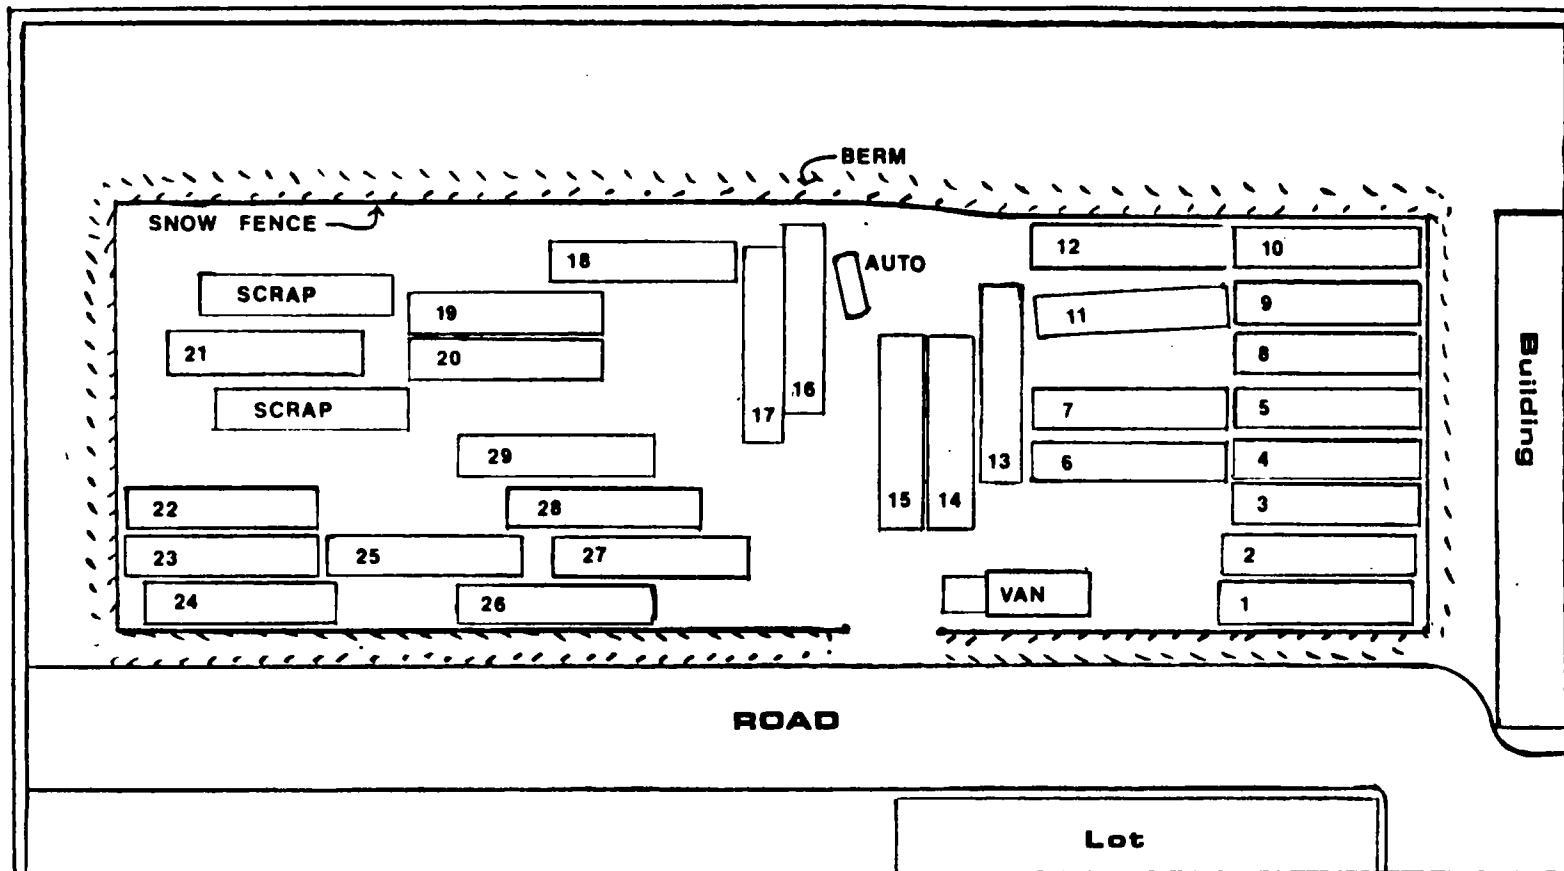
**Figure 1**

On 14 October 1983, TAT member Stofferahn met with Troopers Koch and DeLacy at District Three Headquarters of the Illinois State Police, 4051 N. Harlem Avenue, Chicago. After a brief explanation as to what the site assessments were to involve, the troopers and TAT proceeded to the Red Devil Manufacturing facility at 5995 North River Road, Rosemont, Illinois (Figure 1). Twenty-nine trailers were numbered with spray paint and categorized. The results of the assessment are given in Table 1. Trailer three was found to contain no waste chips. All other trailers were noted to be leaking or seeping leachate to some extent. Five trailers, numbers 13, 15, 18, 27 and 28, were recommended by the officers to be offloaded. The trailers are confined to a small bermed area, and little room to access the majority of the trailers exists. A small asphalt lot was noted across the street from the site which could potentially be used to temporarily store the structurally sound units while the others are being repaired or off-loaded. No information as to the owner of this lot was available at this time.

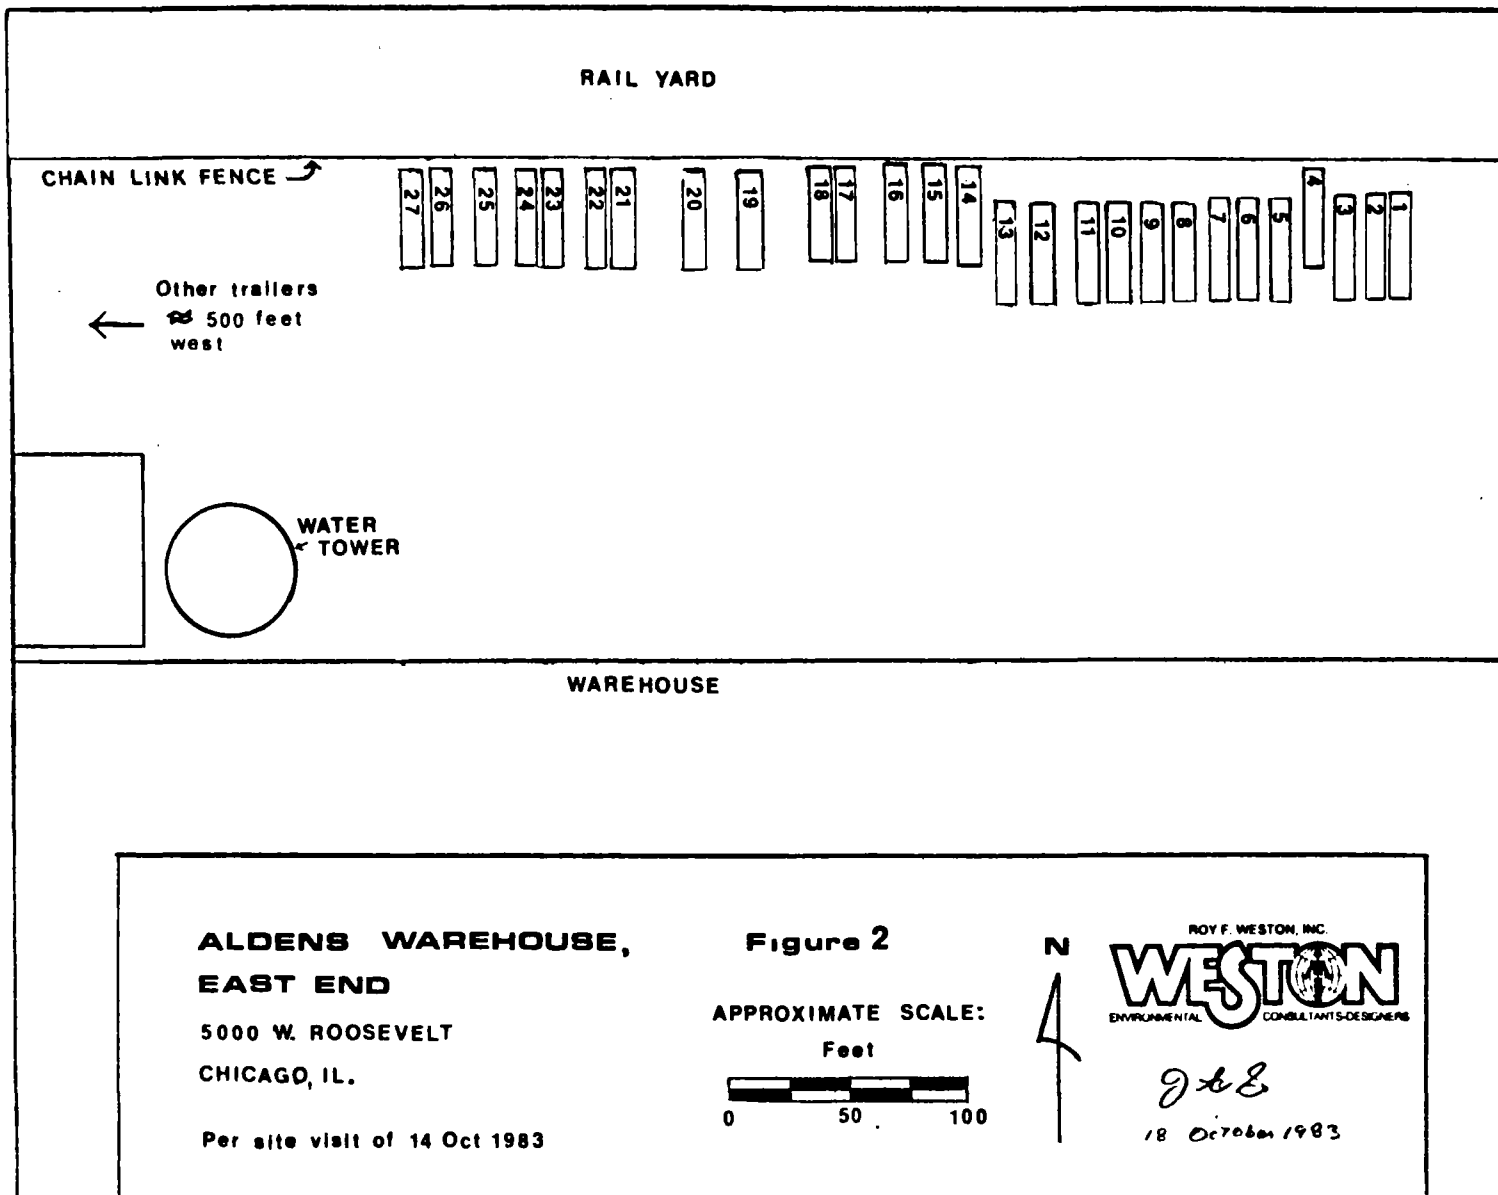
**Figure 2**

From the Rosemont site, the troopers and TAT proceeded to the abandoned Aldens warehouse site at 5000 W. Roosevelt, Chicago (Figures 2 and 3). Thirty-seven trailers containing chips were numbered with indelible markers. Twenty-seven of these trailers contain chips which were treated with sodium hypochlorite solution by Petrochem Services, Inc., during a state-funded Emergency Action this last summer. Recent analyses, however, have shown these chips still contain significant levels of cyanide and were included in the assessment. The results of the assessment are given in Table 2. Again, all the trailers showed signs of leakage or seepage of leachate (as the weather as been relatively dry prior to the site visits, most of the trailers at this and the Rosemont site were not actively leaking, but showed definite signs of past leakage). The troopers recommended that ten trailers, numbers 2, 3, 5, 11, 17, 30, 32, 33, 34 and 35, should be off-loaded. The trailers are situated on a

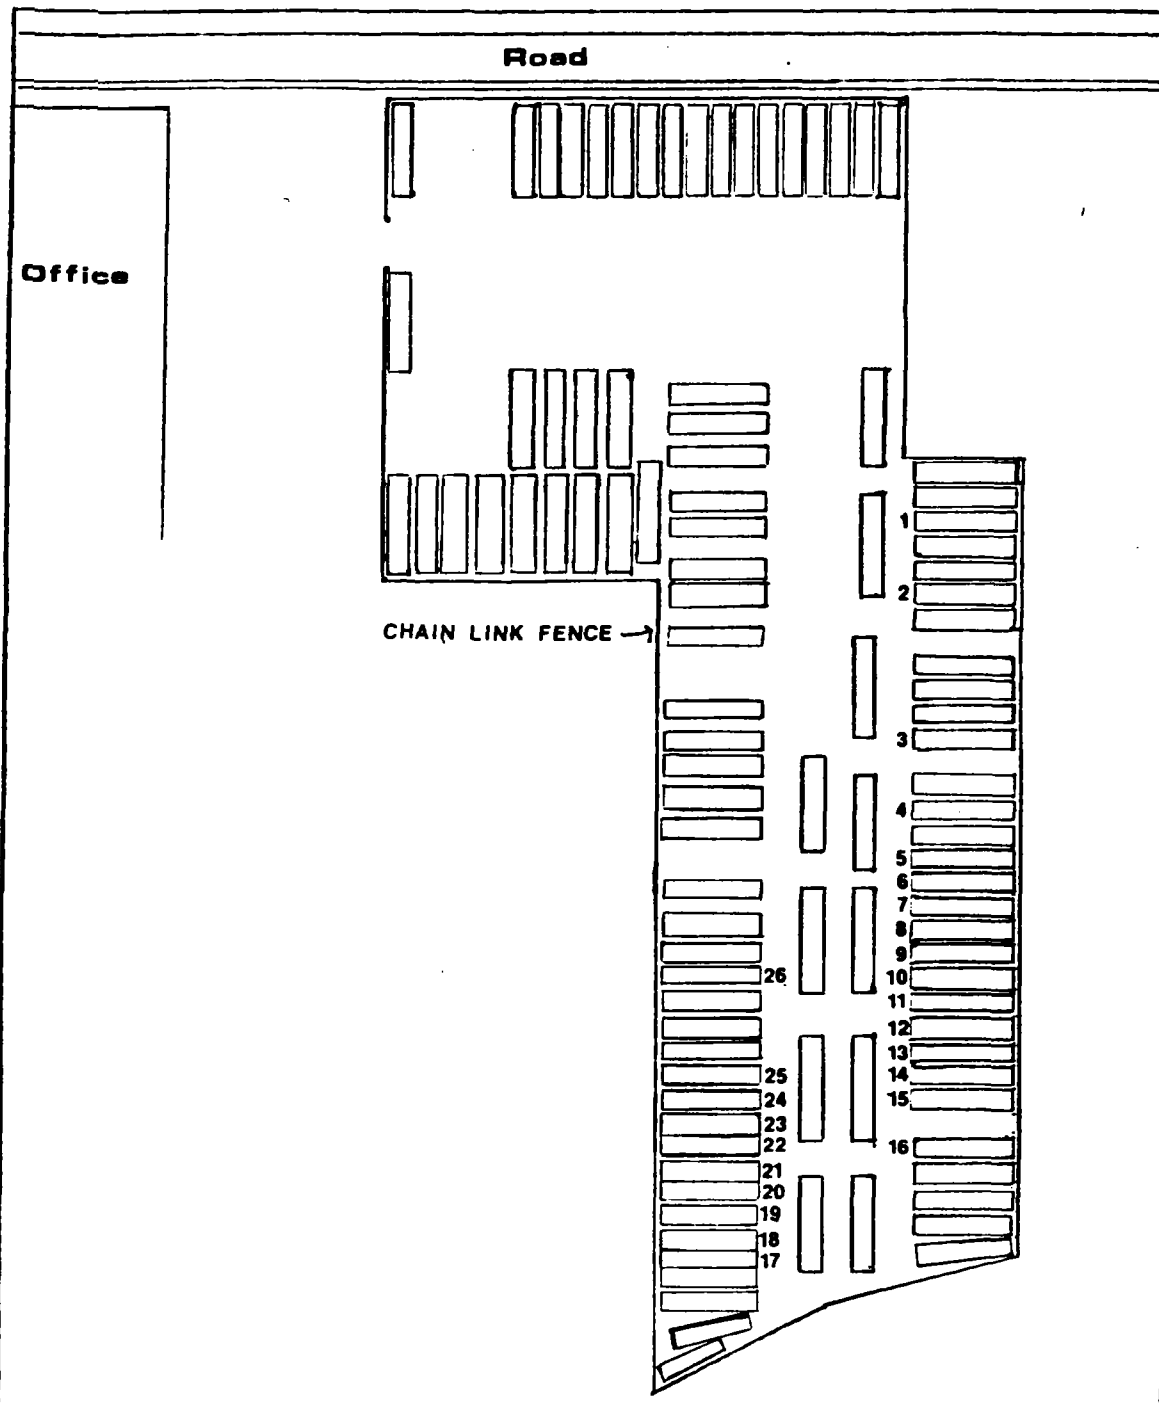
**GEMINI LEASING (RITE-WAY) Figure 4**

On 17 October 1983, TAT member Stofferahn met with Sargent Underwood and Troopers Zipsie and Patterson from District Four State Police Headquarters (13863 S. Cicero, Crestwood, Illinois) at the Gemini Leasing yard, 6021 S. East Avenue, Hodgkins, Illinois (Figure 4). The Gemini Leasing yard is an active facility. Twenty-six trailers containing waste chips located here were numbered with indelible markers. The results of the assessment of these trailers are given in Table 3. Most of the trailers were leaking; some were without jack stands. Nine trailers, numbers 11, 12, 14, 17, 19, 22, 23, 25 and 26, were recommended for offloading by the troopers. While gaining access to the twenty-six trailers will require only a minimal amount of movement of other units on the yard, acquiring room for repairs and offloading will be a problem due to the fact that this is an active place of business. The owner of the yard, who TAT met briefly during the site visit, complained that the waste trailers were taking up space on his yard which he could be utilizing for paying customers. The addition of ten more trailers, or several roll-off boxes, to store the chips from the ten unsound units is not anticipated to elicit a favorable response from Gemini officials.

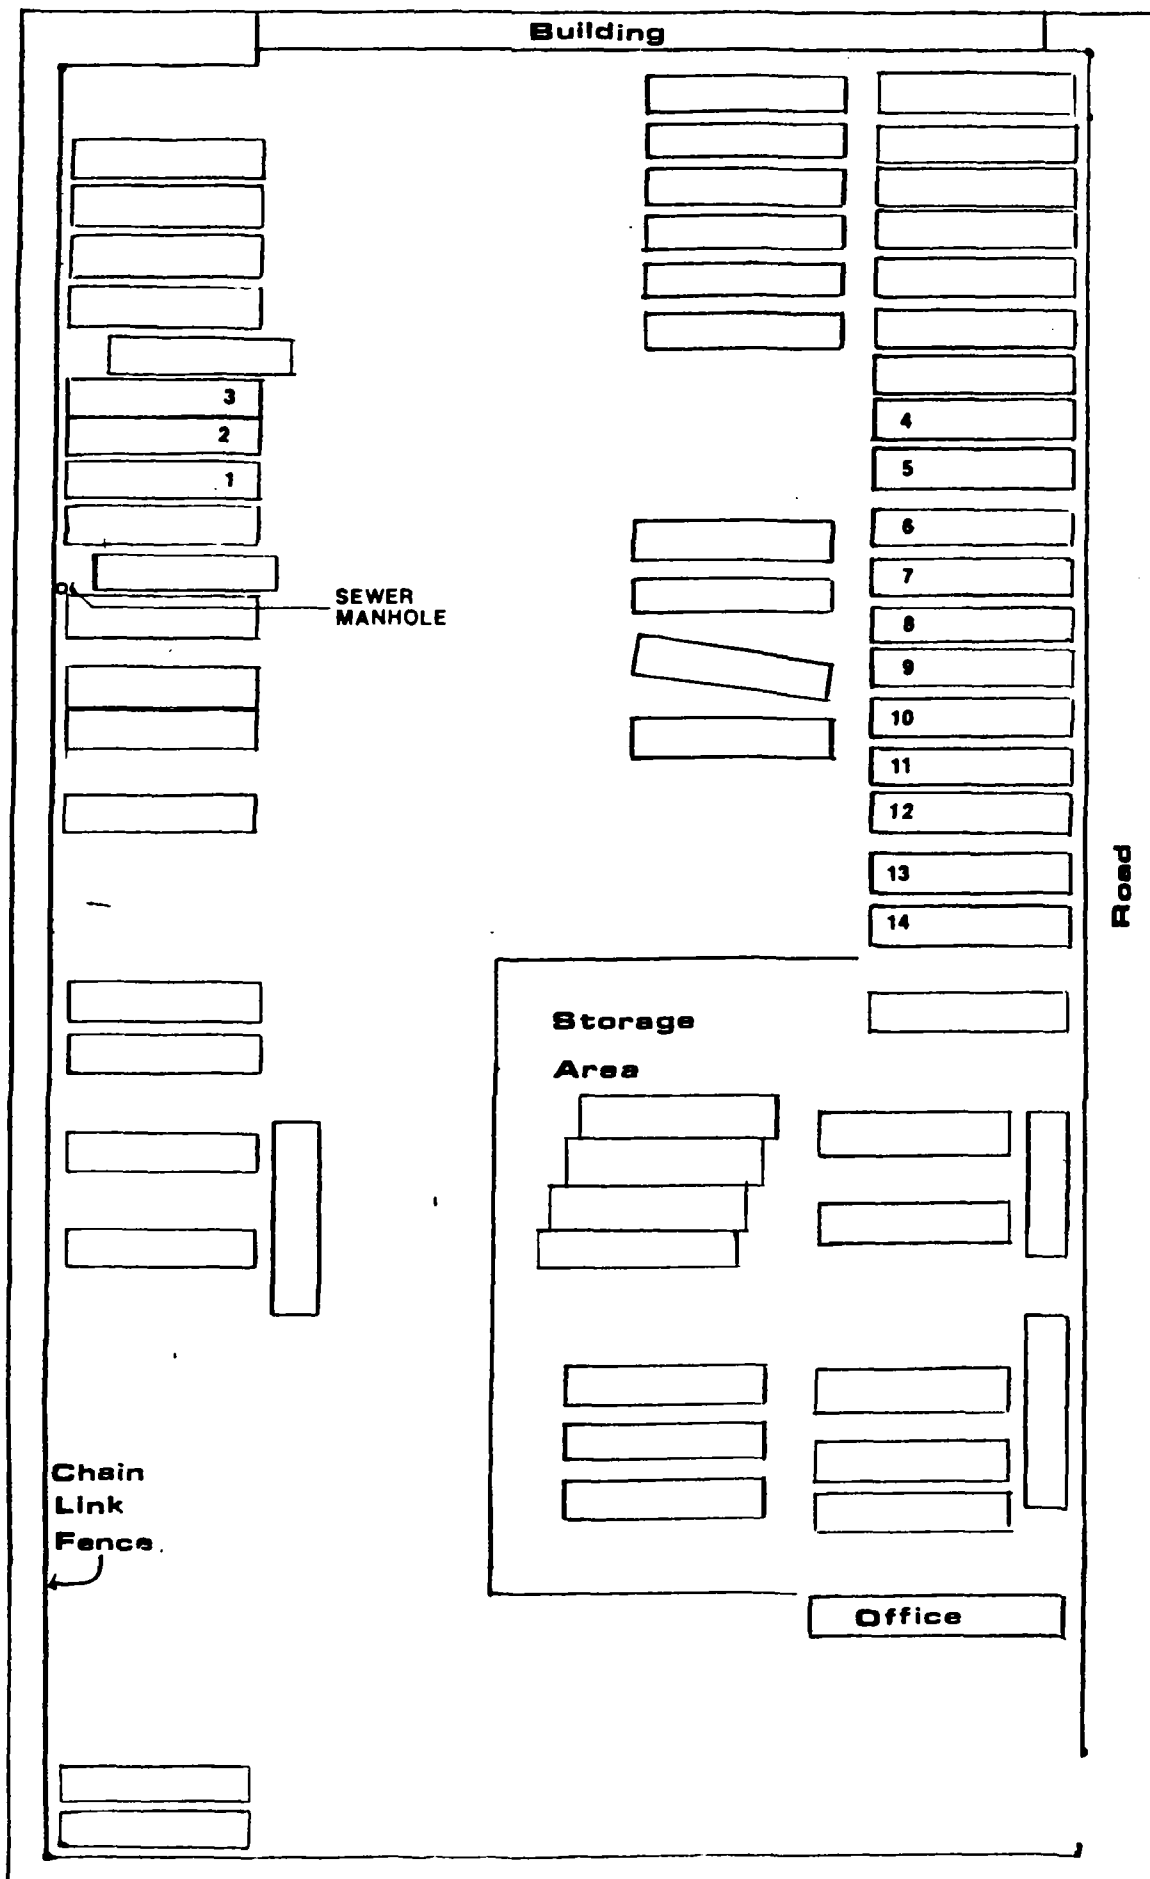
Figure 5

The next site assessed was J's Mobile Semi-Trailer Repair yard at 8765 W. Joliet Road, McCook, Illinois (Figure 5). Fourteen trailers located here were numbered and assessed. The results of the assessment are given in Table 4. Leakage of leachate from these trailers had been found to be migrating off site via a storm sewer by personnel from the Metropolitan Sanitary District of Greater Chicago (MSD) in September of 1983. Four trailers, numbers 1, 3, 6 and 7, were recommended to be offloaded. As with the Gemini Leasing yard, this is an active trailer yard. Access to the waste trailers is not anticipated to be a serious problem; however, finding enough room for repairs and offloading is.

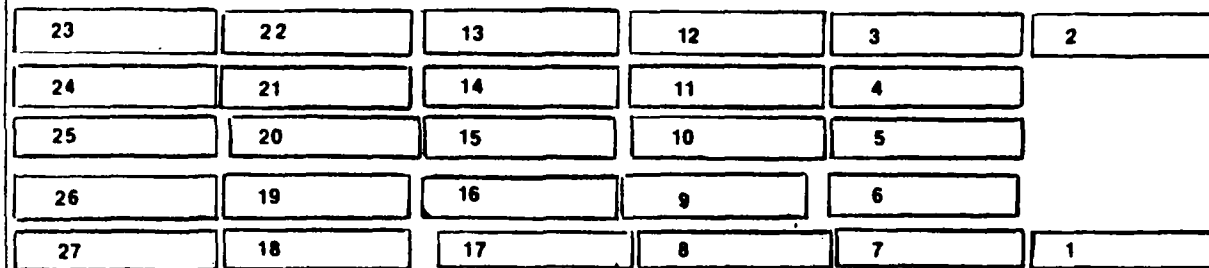
**EAGLE TRAILER INC. Figure 6**

The Eagles Trailer yard at 7710 W. 57th Street, Summit, Illinois (Figure 6), was the next site visited. Twenty-seven trailers containing waste were numbered and assessed. The results of the assessment are given in Table 5. As with the J's site, off-site migration of cyanide via a drainage ditch along the southern parameter of the site was documented by the MSD last September. Three units, numbers 2, 4 and 16, were recommended for off-loading. A considerable access and congestion problem was noted at this site. There is a totally inadequate amount of space within the area where the trailers are parked for any amount of work to be done. The trailer repair yard to the north is active, and cannot be used. The paved area leading to Archer Avenue could be used for temporary storage of sound units. To the northeast, TAT noticed a very large paved parking lot and what appeared to be abandoned buildings. This lot could also potentially be utilized for temporary storage or working space. An Eagle's employee stated this facility was owned by Ryder P.I.E., and supplied TAT with a business card for a contact with the firm (Attachment 1).

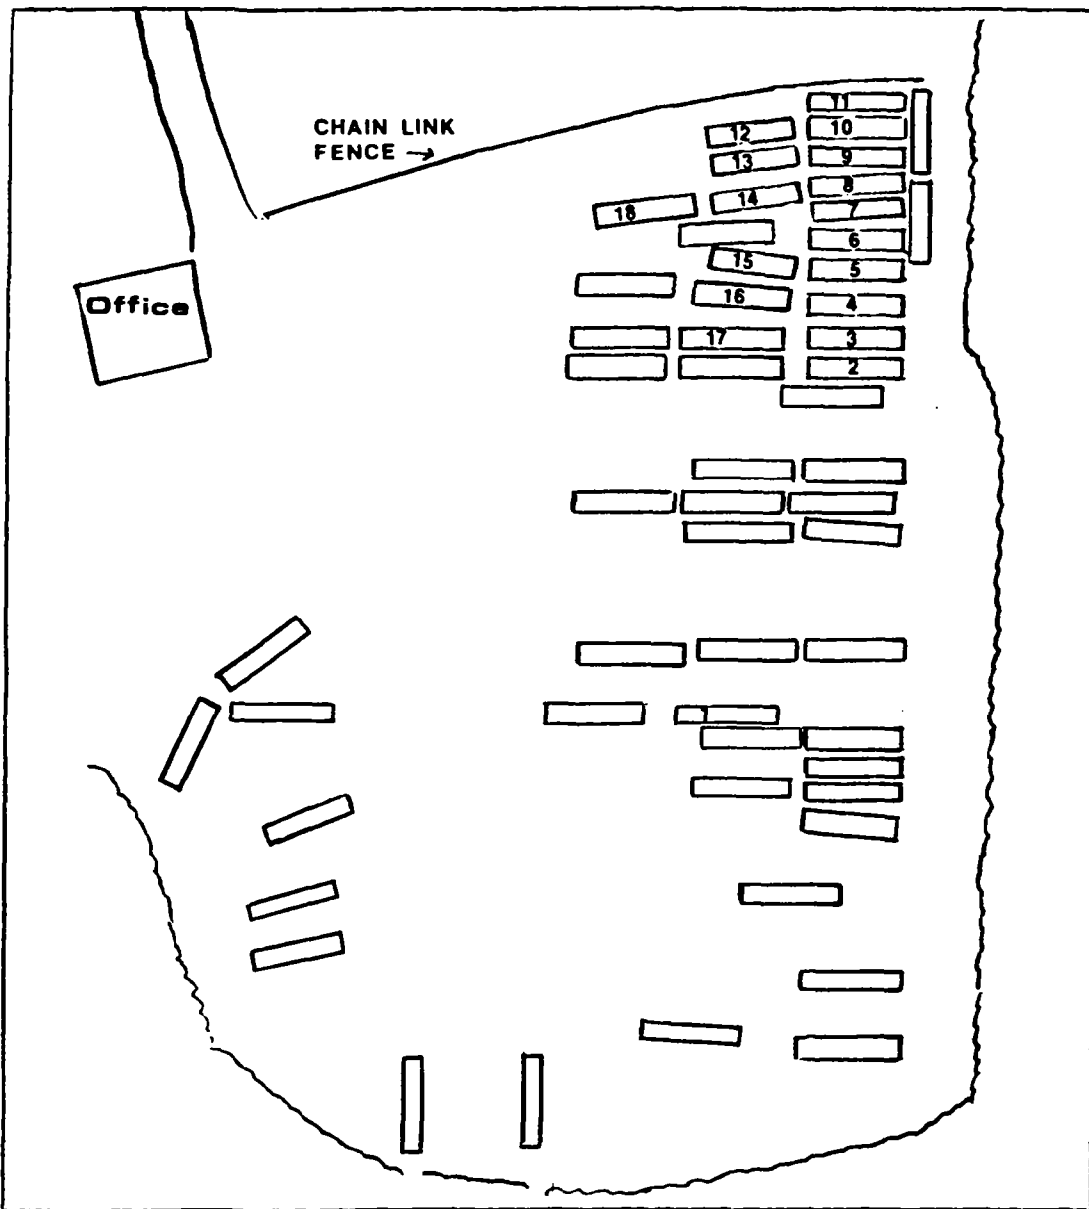
## **Figure 7**

The Livco trailer yard at 6700 W. 130rd Street, Chicago Ridge, Illinois, (Figure 7), was the last site visited. Eighteen trailers containing waste were numbered and inspected at this facility. Table 6 provides the results of this assessment. All the units were leaking or seeping leachate, but only one, number 55, was recommended for offloading. While this is also an active facility, no significant access or congestion problems are anticipated.
